## Adjustments to remove worm gear backlash on 1200GTO mounts equipped with spring-loaded action brackets.

These instructions are for 1200GTO German Equatorial mounts shipped after 5-26-04 (serial number 1200432 or later) or any 1200GTO mount that has these upgrades: 1200GTO RA Motor bracket with Spring - Loaded Action (purchased as part number 12SLBR or M12270-B) or 1200GTO Declination Motor Bracket with Spring -Loaded Action (purchased as part number 12SLBD or M12560-B).

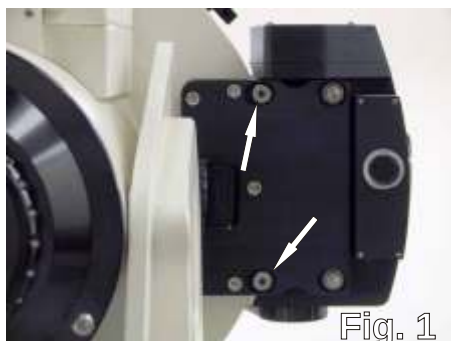
Fig. 1

Do not loosen or adjust the two shoulder bolts on the mounting bracket. (Marked by arrows in figure 1) Although they are attached to the worm housing that you will be adjusting, they are not in contact with the mounting bracket. Their roll is of a safety or supportive nature for the bracket. They should be left at the tightened factory setting.

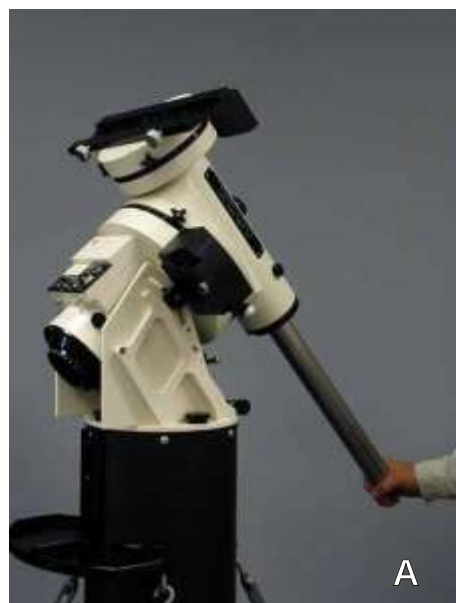
A

Step 1-Place your hand near the end of the counterweight shaft and move the shaft back and forth as if to rotate the RA axis. This test can be done with the mount alone on its pier or with the telescope and counterweights attached. (A)

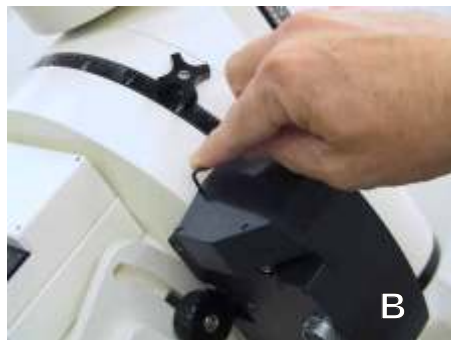
B

Step 2 - Using a 5/64 inch long-arm hex key, loosen and remove all six 2-56x3/4 SHCS retaining the cover. (B)

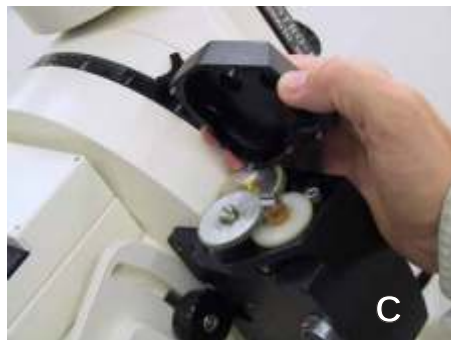
C

Step 3 - Remove the cover to expose the reduction gear set. Take note of the aluminum gear that is in the front. (C and D) (See arrow on D)

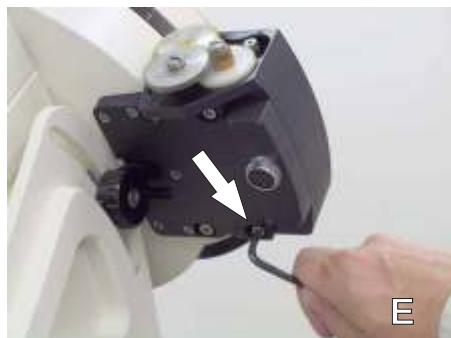
E

Step 4 - Using a 5/32 inch long arm hex key, completely loosen only the one socket head cap screw shown. (E)

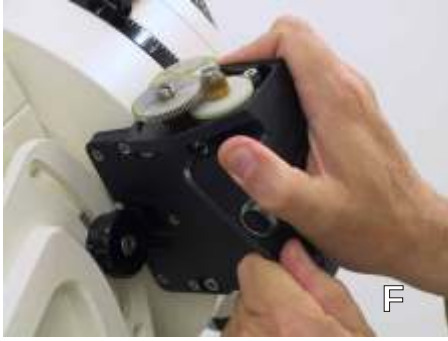
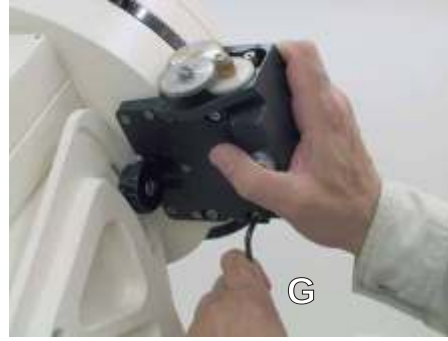
Step 5 - Place one hand firmly upon the gear housing. Apply pressure on the housing in the direction of the main body of the mount. Maintaining pressure, use your 5/32 hex key to slowly loosen the second socket head cap screw shown. Retighten the second screw after movement is felt or it becomes loose, maintaining pressure as you do. (F)

Step 6 - Continuing to apply some pressure, retighten the first screw. (G)

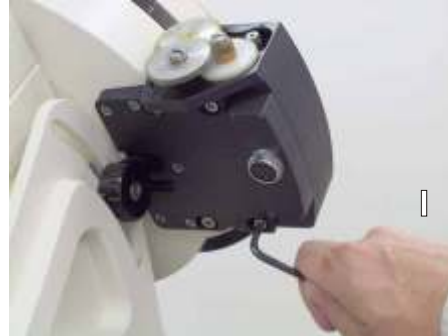
Step 7 - Repeat step #1 to see if backlash has been removed. If backlash remains go back to step #4 and give it another try. (H, I)

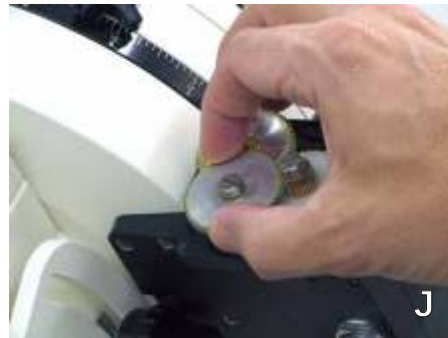
Step 8 - If the backlash is gone, verify that the worm gear is not too tightly meshed by rotating the aluminum gear shown in photo (J). If the gear can be turned and no backlash is felt, using step #1, you are finished. If the gear is too tight to turn by hand, move to step #11. (J)

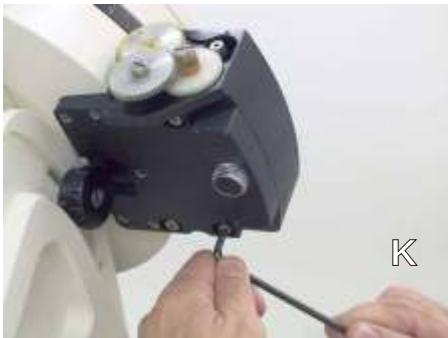
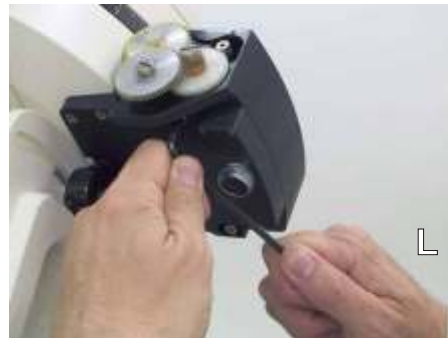
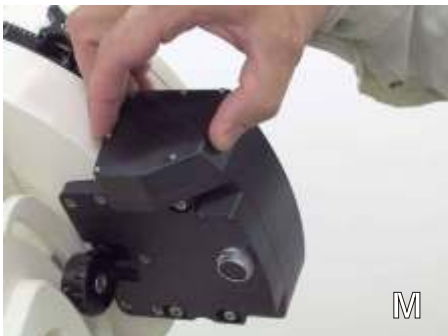
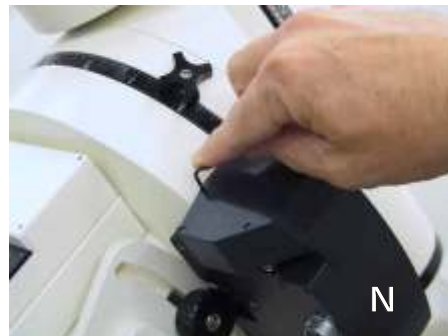
Step 9 - Make a final check of the tightness of the two screws. Rotate the aluminum gear one more time. (K, L, J)

Step 10 - If the adjustment is correct, return the cover to the gear housing and reinstall the six 2-56 SHCS. (M, N)

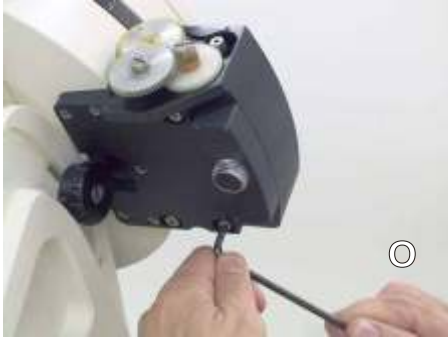
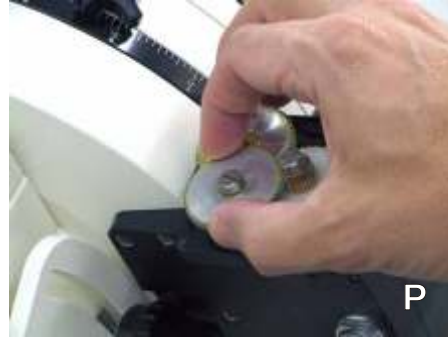
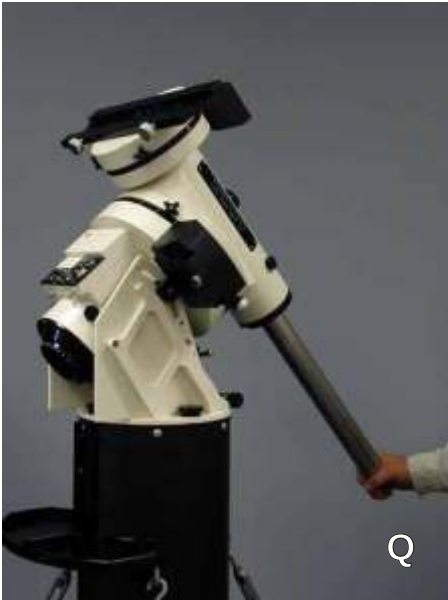
Step 11 - If the worm gear is too tight, and it is difficult to rotate the aluminum spur gear, try the following solution. Loosen the first screw again. (O) With no hand pressure applied to the housing, attempt to rotate the aluminum spur gear again. (P) The rotation of the spur gear should release the excess pressure between the worm and worm wheel. If it does, retighten the screw and check for backlash play as in step #1. (Q)

If the aluminum spur gear cannot be rotated with the actions in step 11, return to step #4 and apply less pressure through steps #5 and #6. Repeat until correct mesh is achieved.

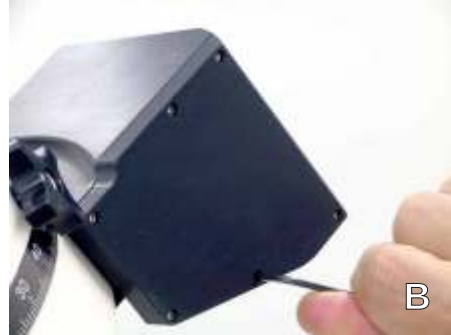
**Do not loosen or adjust the two shoulder bolts on the mounting bracket. Marked by arrows in Figure 2. Although they are attached to the worm housing that you will be adjusting they are not in contact with the mounting bracket. Their role is to protect the bracket and should be left tightened.**

Step 1 - Place your hand near the end of the telescope focuser or cradle plate and move the scope back and forth as if to rotate the Declination axis. This test can be done with the mount on its pier or with the telescope and counterweights in place.

Step 2 - Using a 5/64 inch long arm hex key, loosen and remove all six 2-56x5/16 socket head cap screws (SHCS) that attach the cover. (B)

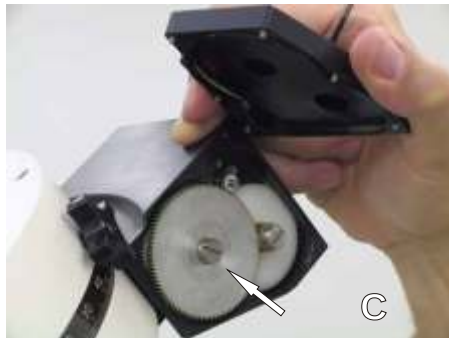
Step 3 - Remove the cover to expose the reduction gear set. Take note of the large aluminum gear. (C)

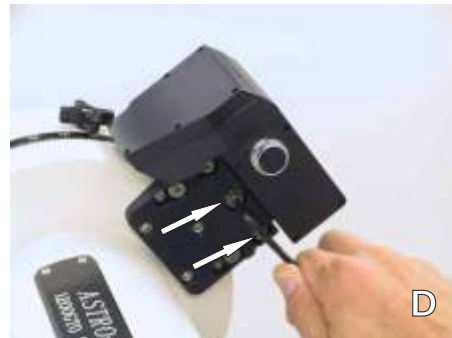
Step 4 - Using a 5/32 inch long arm hex key, completely loosen only the two socket head cap screws shown. (D)

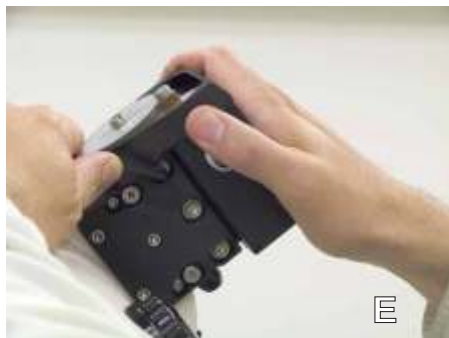
Step 5 - Place one hand firmly upon the gear housing. Apply pressure on the housing in the direction of the main body of the mount. Maintain pressure while using your 5/32 hex key to slowly loosen the third socket head cap screw shown. As the screw is loosened you may or may not feel a slight movement of the housing. Retighten the third screw after movement is felt or it has become loose, maintain pressure as you do. (E)

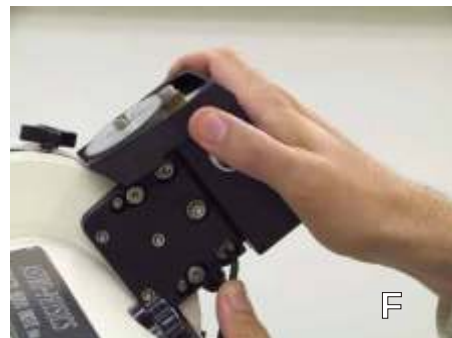
Step 6 - Continue to apply some pressure while tightening the first two screws loosened earlier. (F)

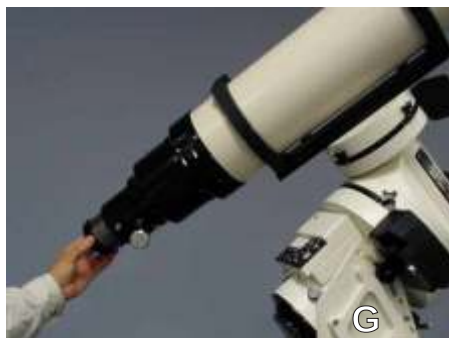
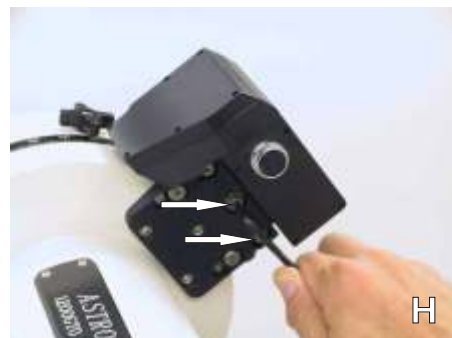
Step 7 - Repeat step #1 to see if backlash has been removed. If backlash remains go back to step #4 and give it another try. (G, H)

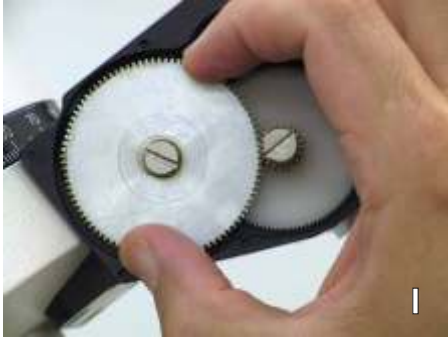
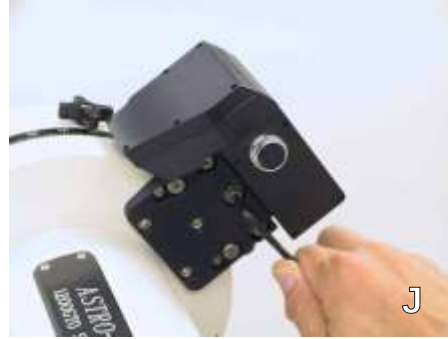
Step 8 - If the backlash is gone verify that the worm gear is not too tightly meshed by rotating the aluminum gear shown in photo (I). If the gear can be turned and no backlash is felt using the procedure in step #1 you are finished. If the gear is too tight to turn by hand, move to step #11.
